## **BALNAHARD FARM COLONSAY**

### **ARCHAEOLOGICAL WALKOVER SURVEY**

### **Data Structure Report**

**May 2012**

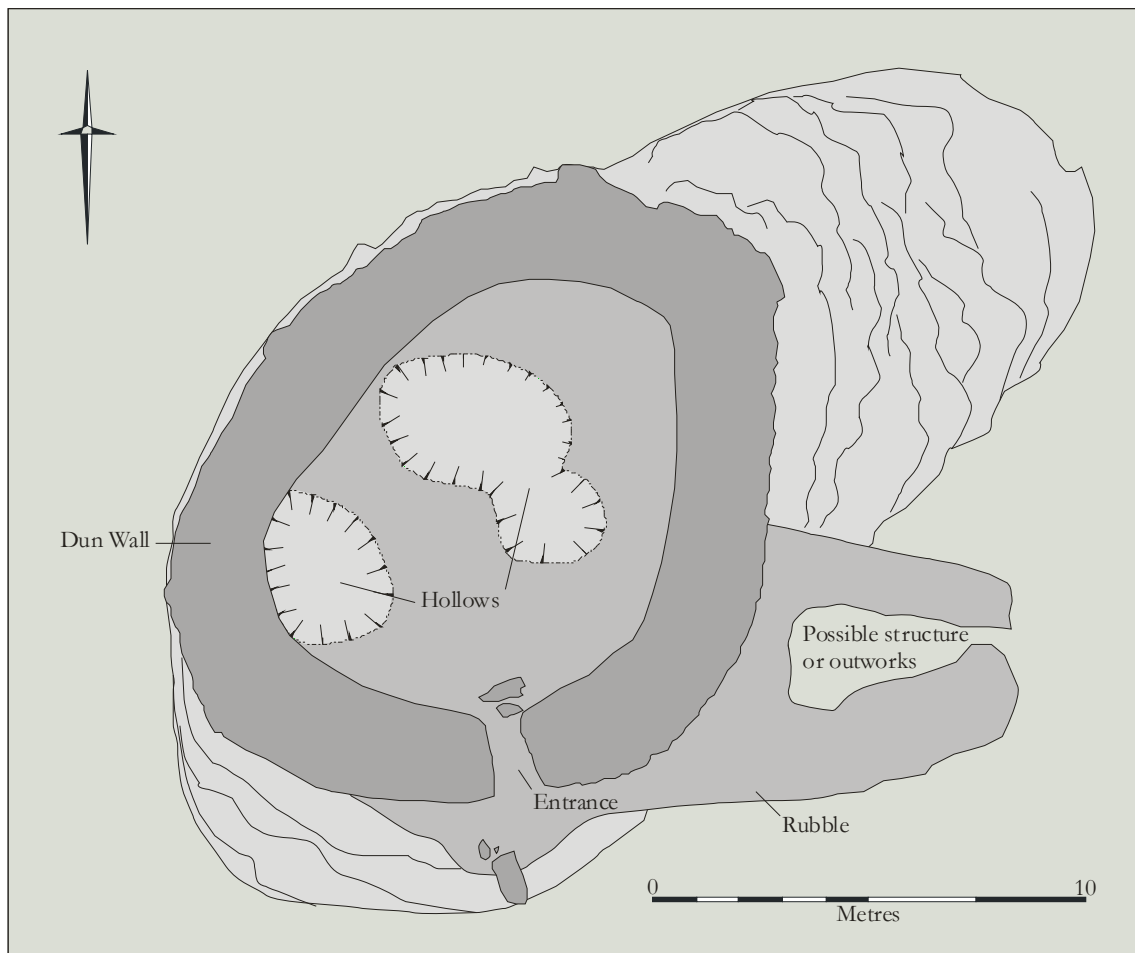
Figure 4: Site 172, Plan of Dun

Three of the above sites have previously been recorded (Site 27, Site 91 and Site 205) but another at Site 172 was an exciting discovery. The site may not have been totally overlooked in the past and may be the Dun Mor referred to by Loder (Loder 1935 p. 27), later misidentified by Piggot and the RCHAMS. The site, like the other fortified sites, likely dates to the Iron Age or early medieval period and occupies a steep ended rocky knoll that enjoys fine views towards the SE and NW of the farm. Loder also relates a story told to Symington Grieve by a Mr Buie of Uragig, that a queen, the richest woman in the world, once lived in the hillforts of Balnahard; whether it was this site remains to be seen.

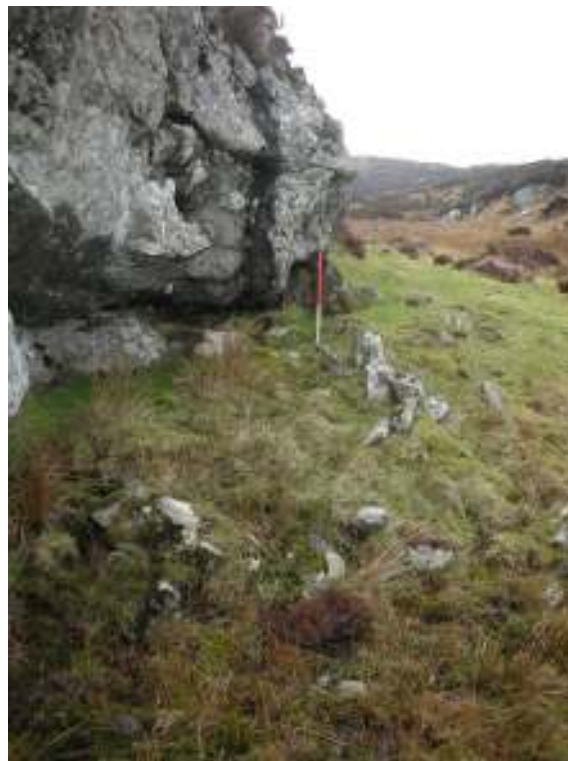
Structure built against rock face at Site 181

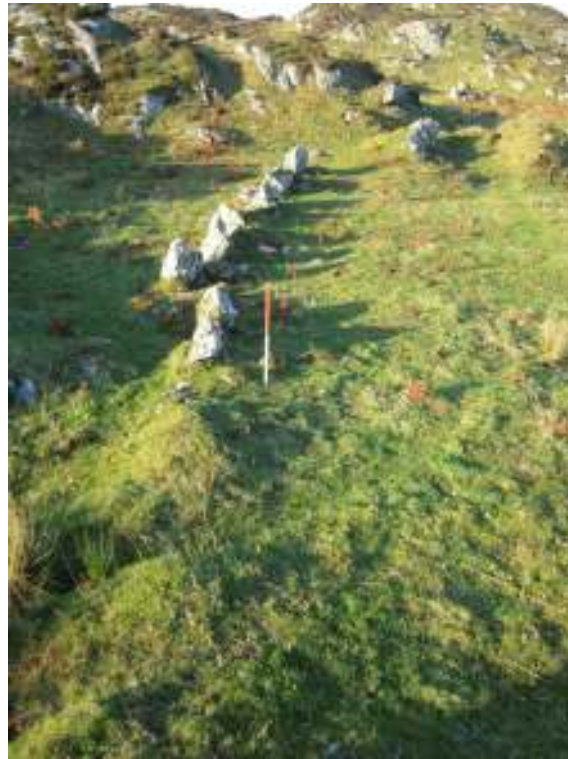
Typical turf and stone dyke at Site 23

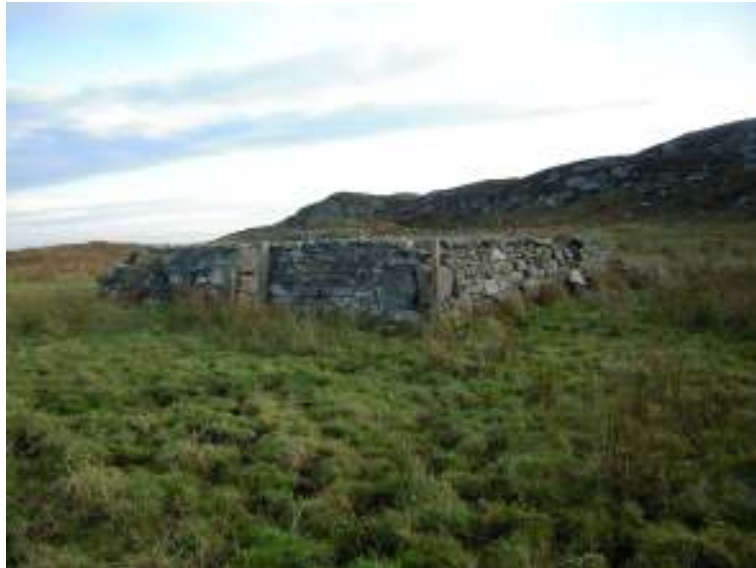
Site 2: Sheep Fank

The upstanding remains of this sheep fank measured 10.50m by 9.90m with walls 1.62m high between 0.70m at base narrowing to 0.40m at a top. The fank appears reduced from its original size with the traces of robbed-out walls on two of the sides; a metal cauldron lies close by.

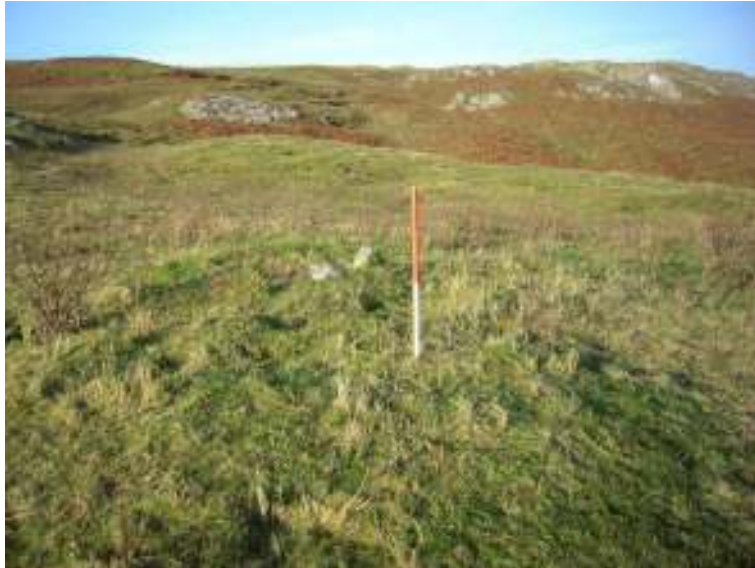
Site 4: Oval Structure

An oval setting of stones that may be the remains of a structure. This measured 5.0m by 4.0m externally and standing one course high.

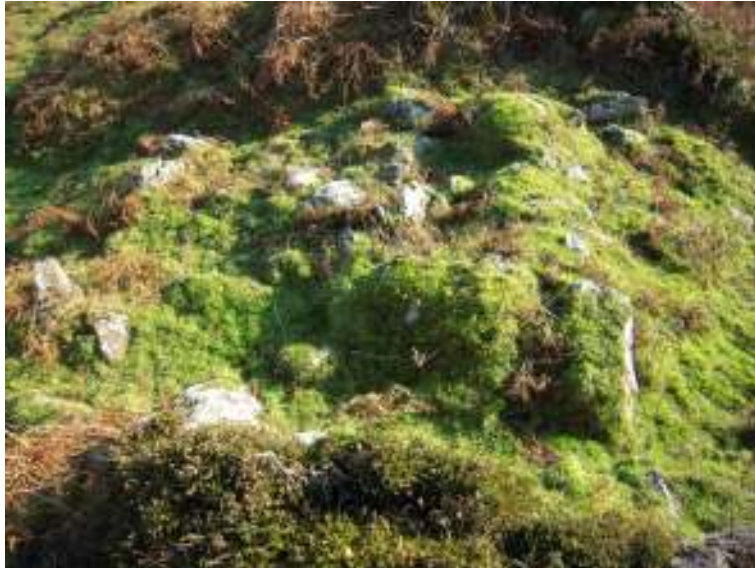
Site 11: Structure

A rectangular structure set against a natural scarp that forms its W side. Measured 4.80m by 3.80m externally with rubble walls standing up to 0.60m high and 0.70m wide.

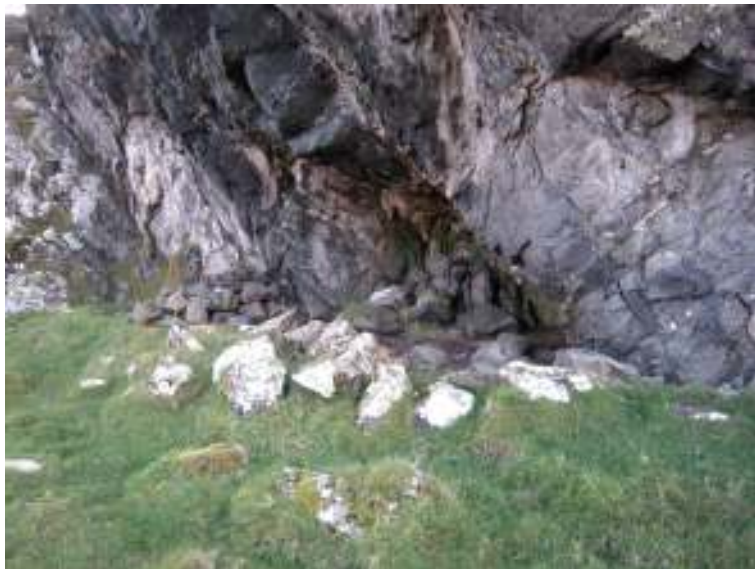
Site 13: Structure or *Squid*

Situated against/beneath the W side of a natural overhang this was the remains of a badly disturbed structure measuring 5.20m by 4.40m externally.

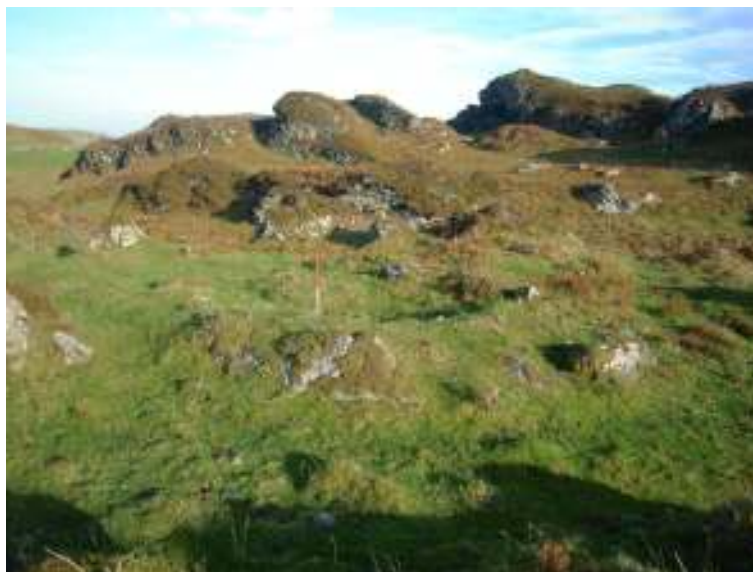
Site 22: Structure

A rectangular structure measuring 6.80m by 5.60m externally, with rubble built walls standing up to 0.30m high and 1.20m wide. There are possibly traces of robbed wall lines that suggest the building may have originally been up to 9.0m long.

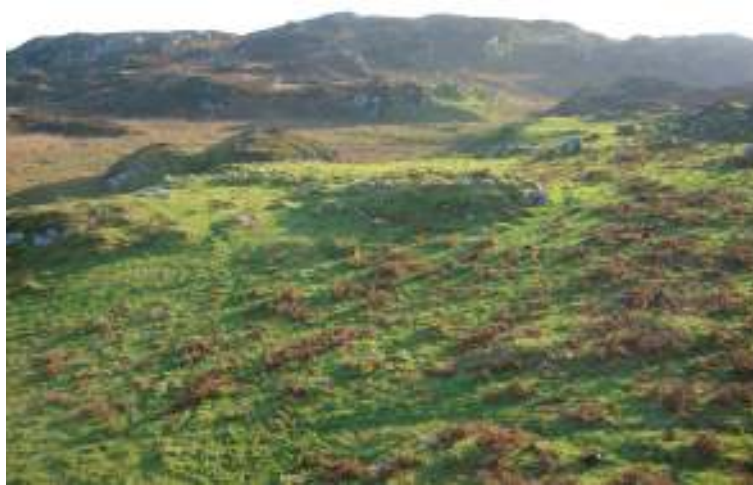
Site 23: Structure surrounded by Cultivated Ground

A complex of related features situated on a level terrace with numerous traces of rig and furrow cultivation. The structure was oval in shape measuring 8.0m by 5.0m externally with walls 0.5-0.6m high. A 16m length of turf and stone dyke runs from its E end to a natural scarp. 33m to the south is a curvilinear enclosure formed by a turf and stone dyke now reduced to a line of stones enclosing an area 35m wide.

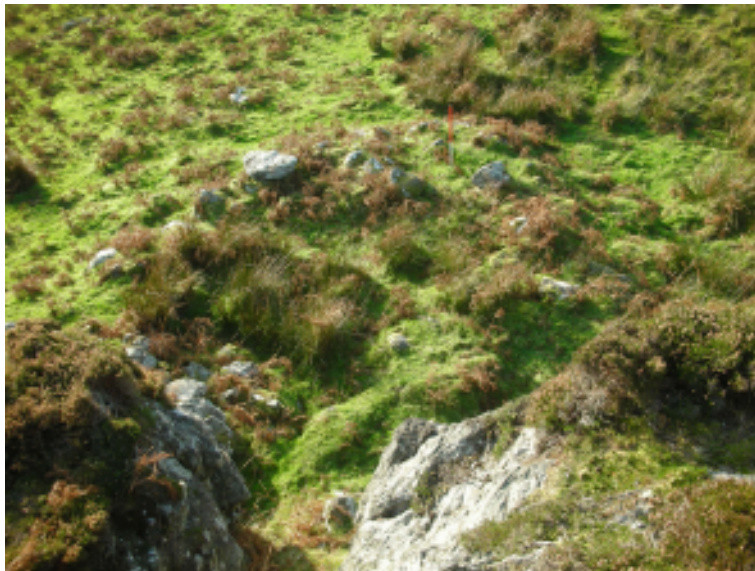
Site 28 iv: Structure

- i) Dyke. NR 44225 99530 6m. A length of turf dyke closing off the terrace at the N.
- ii) Dyke. NR 42239 99504. A length of dyke closing off the terrace on the W.
- iii) Dyke. NR 42238 99487-NR42220 99481. An E-W aligned dyke dividing the terrace.
- iv) Structure. NR 42242 99476 41m. An oval ended structure with the W end built against a natural scarp. Measures 7.30m by 5.60m with a possible entrance at the SE.

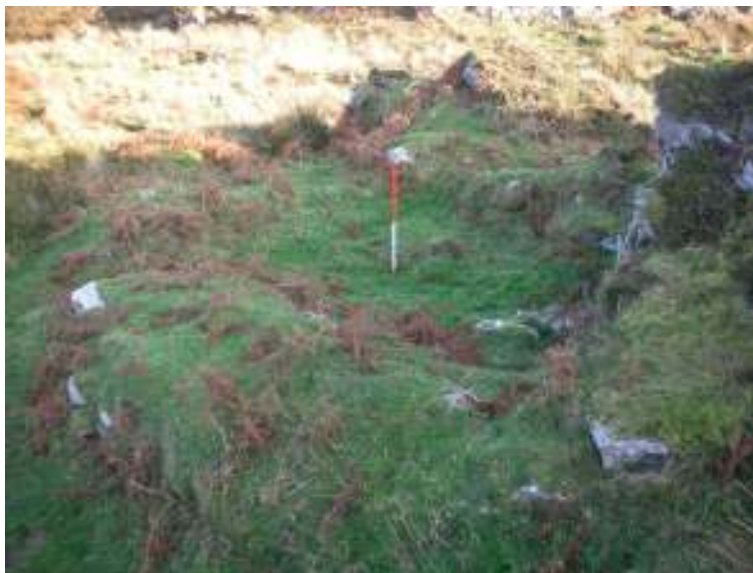
Site 28v: Structure

- v) Structure. NR 42217 99477 46m. This was constructed against a natural scarp that forms its W side Measures 5.60m by 4.90m externally with rubble wall standing 0.50m high and 1.20m wide.
- vi) Structure and Dyke. NR 42252 99479. This was constructed against the N face of a natural scarp and measured 6.0m by 3.0m. An attached wall closes off this side of the terrace.
- vii) Dyke. NR 42247 99463 - NR 42227 99463 42m. An E-W aligned dyke dividing the terrace.
- viii) Structure. NR 42218 99462 47m. This was constructed against the N face of a natural scarp and measured 56.0m by 3.0m externally.

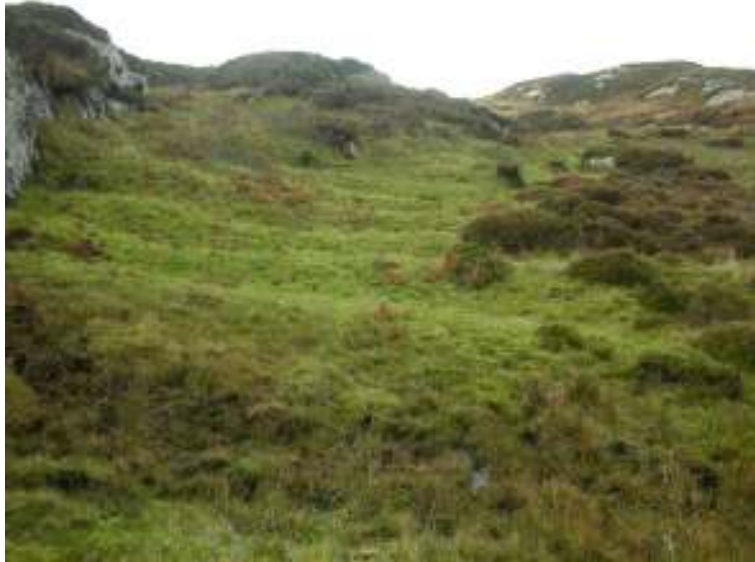
Site 34: Rig and furrow cultivation

- 33) Twinning pen. Cnoc Corr, NR 42740 99688 42m.  
A rubble built twinning pen measuring 2.2m by 1.4m standing 0.6m high.
- 34) Enclosure dyke and Cultivation Remains. Traigh Ban, NR 42633 99803 21m.  
An area of rig and furrow cultivation with the rigs 3m apart.

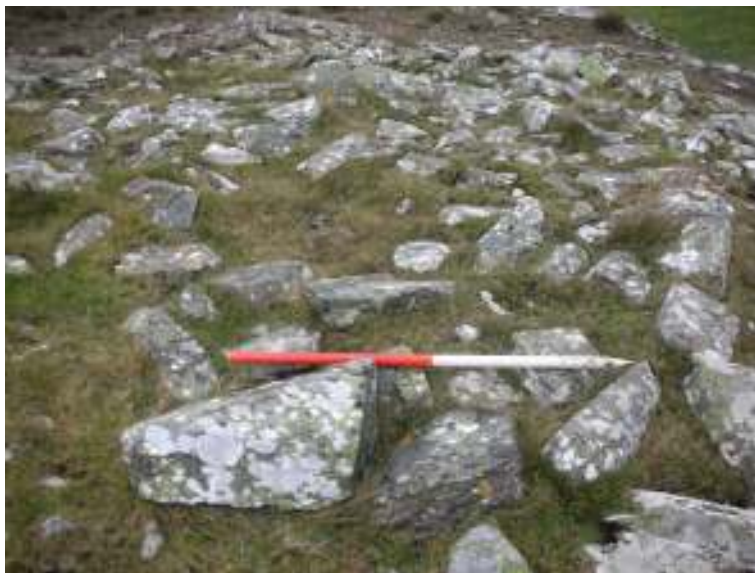
Site 37: Possible burial cairn

On one of the highest points of Leac Bhuidhe are what appear to be the footings of a cairn delineated by two rings of stones set on edge, forming an inner and outer circle. The outer circle measures 4.8m by 5.0m, the inner circle 3.0m by 2.8m. A small marker cairn is situated at the E.

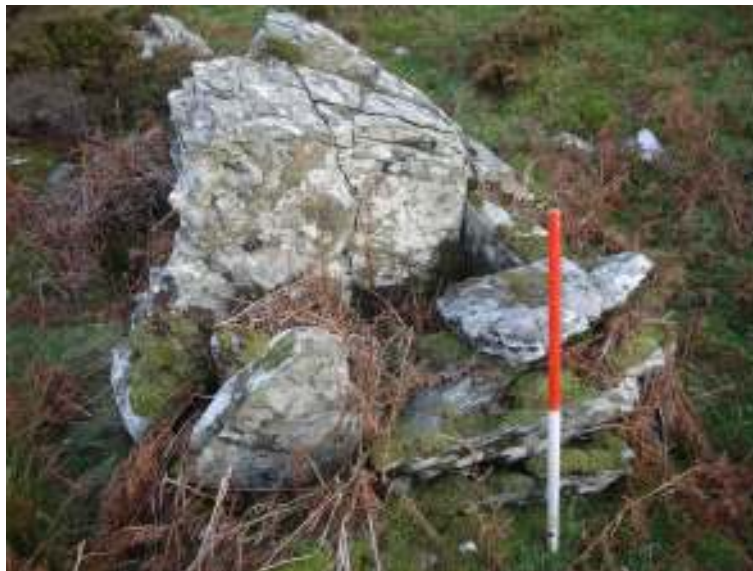
Site 39: Well?

Small rectilinear structure constructed against a large natural boulder, measured 1.50m by 0.95m and standing 0.93m tall. Possibly too small to be a twinning pen.

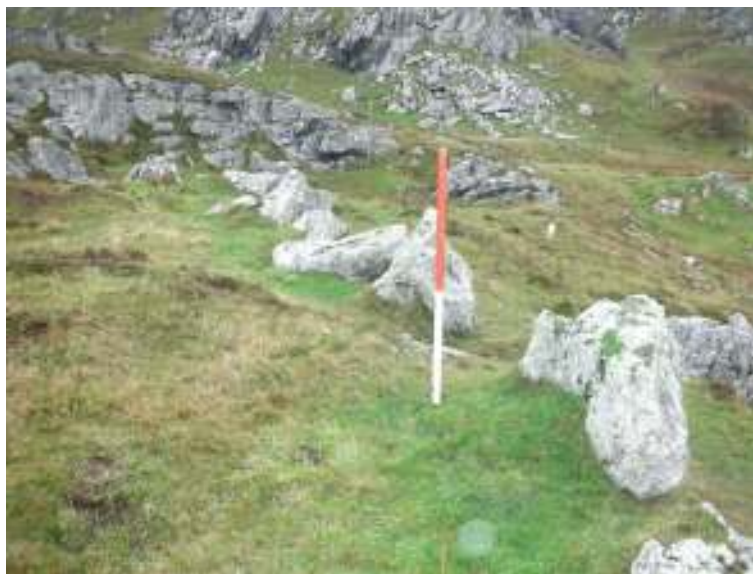
Site 49: Stone dyke

Remnants of a turf and stone dyke now represented by a line of upstanding stones.

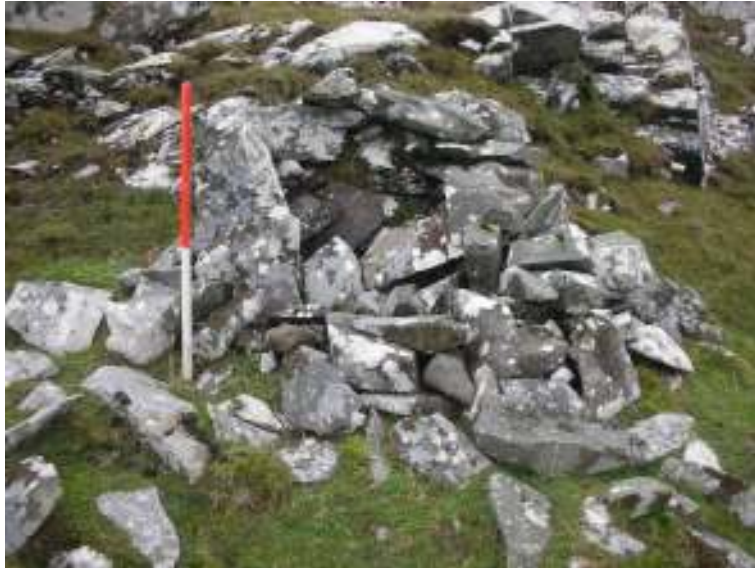
Site 51: twinning pen

A rubble built twinning pen constructed against a natural scarp and possibly constructed from/over the remnants of an earlier and larger structure.

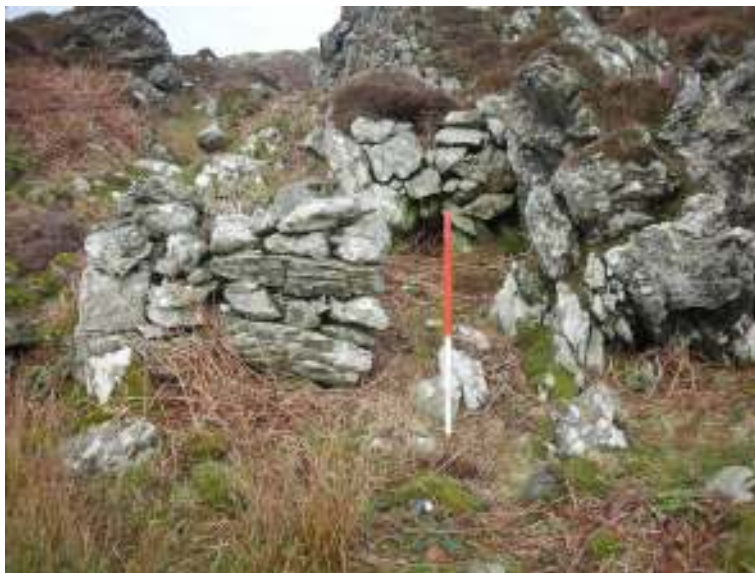
Site 80: Structure

Constructed up against the W face of a natural scarp and measuring 5.0m by 2.5m.

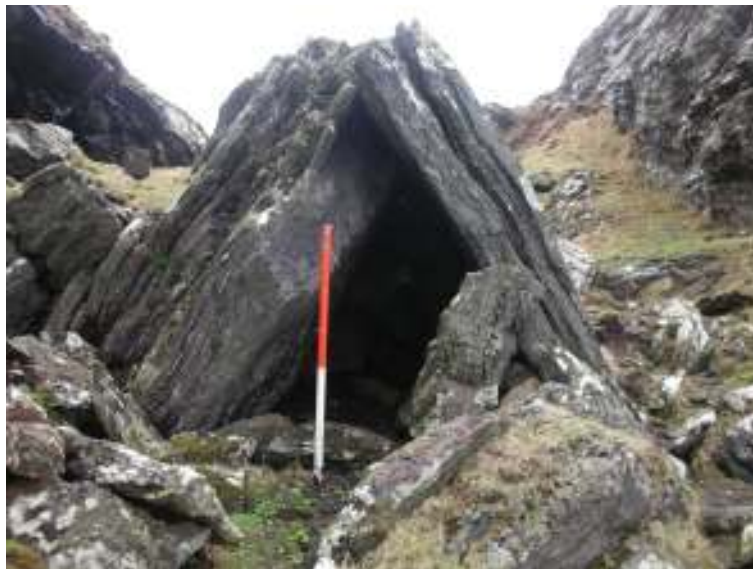
Site 85: shelter in natural rock collapse

A small shelter formed from two large natural stone slabs. This site had previously been recorded as a possible shelter formed of large angular slabs of rock that have fallen from the adjacent cliffs. The slabs form a tent-shaped structure, the floor of which has been flattened. The entrance is to the NW and further flat slabs have been placed to partially block it. The interior is 1.5m wide at the entrance and 2.5m long.

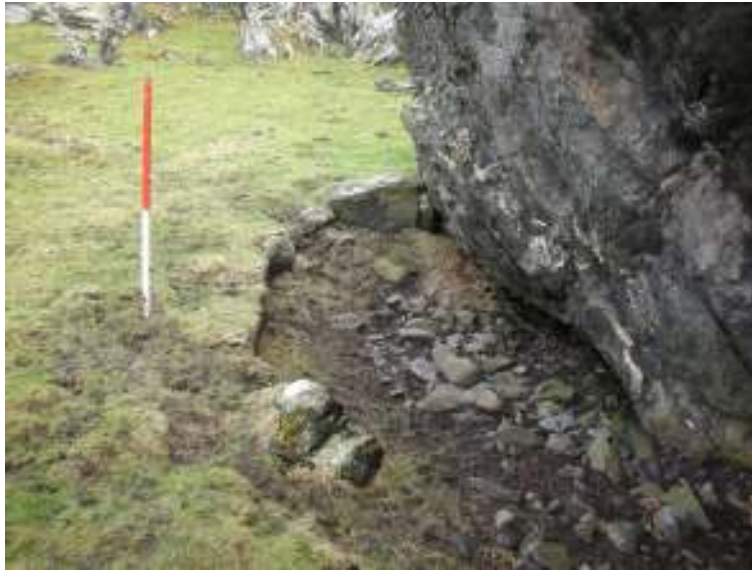
Site 86: Structure

A small structure built against natural rock face, measures 3.00m by 2.00m internally within rubble walls.

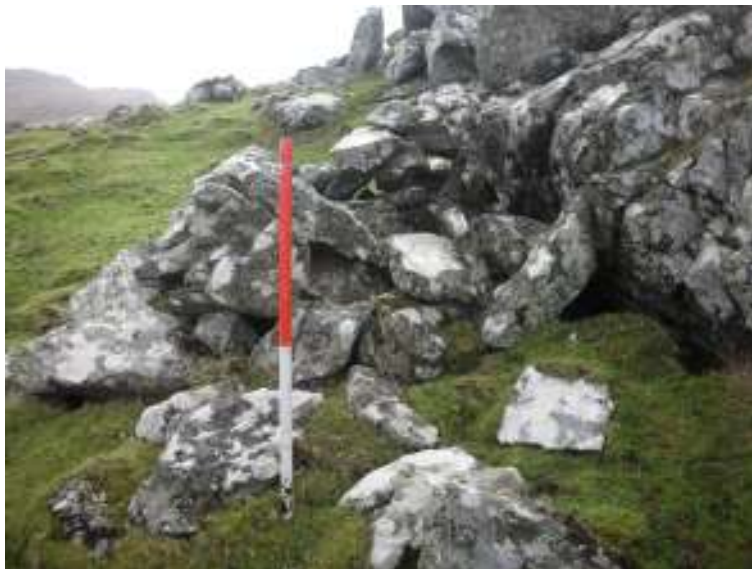
Site 87: Structure

A rectangular structure built within a natural rock crevice. Originally measured 2.70m by 2.60m but modified at a later date to measure just 1.50m wide internally.

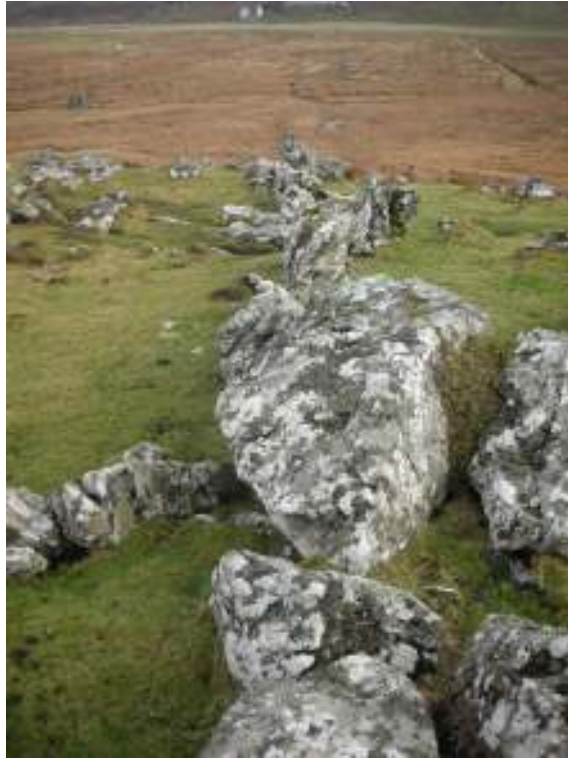
Site 88: Stone dyke

The remains of a stone and turf dyke, now represented by a line of large angular boulders. This site had previously been recorded as SCAPE 248.

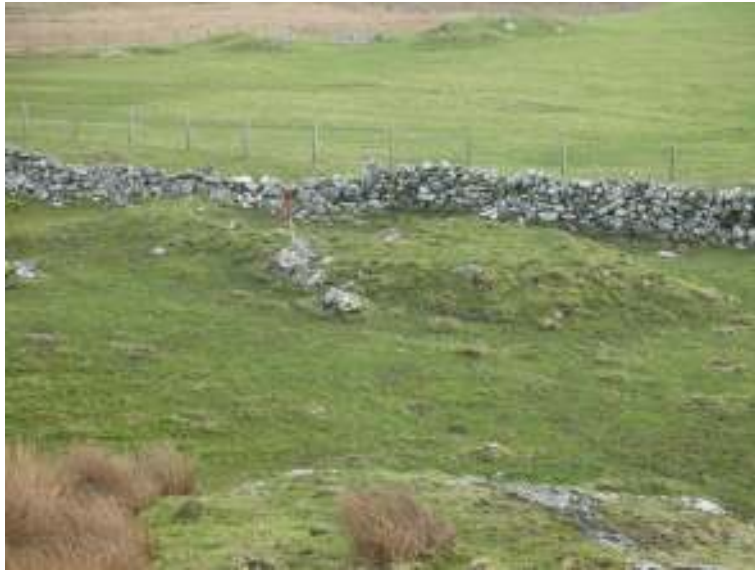
Site 92: Structure

An oval structure attached to a turf and stone enclosure dyke that may have the remains of another structure attached at the NW. The structure measures 9.0m-10.0m by c5.0m. A small clearance cairn lies to the N. This site had previously been recorded.

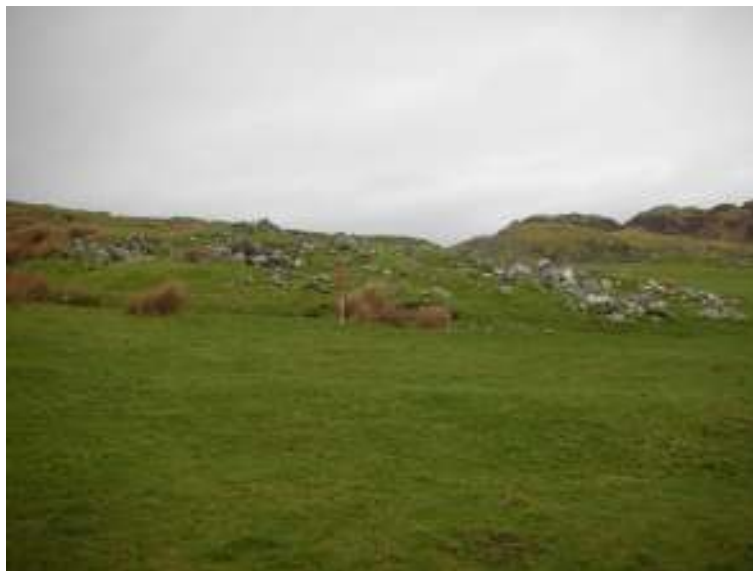
Site 97: Cairn

A large disturbed cairn measuring 20.0m by 18m and standing c. 1.20m high.

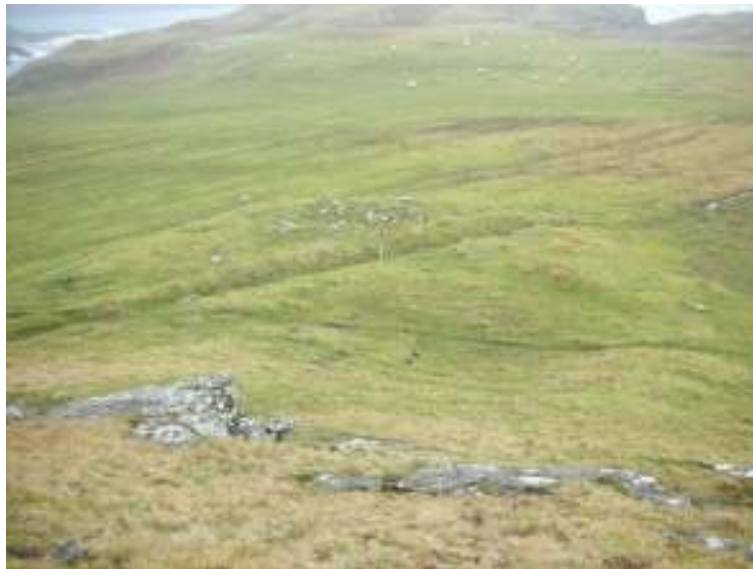
Site104: Possible Structure

The possible remains of a structure consisting of a rubble spread measuring 13.0m by 11.0m and cut through by a drainage ditch.

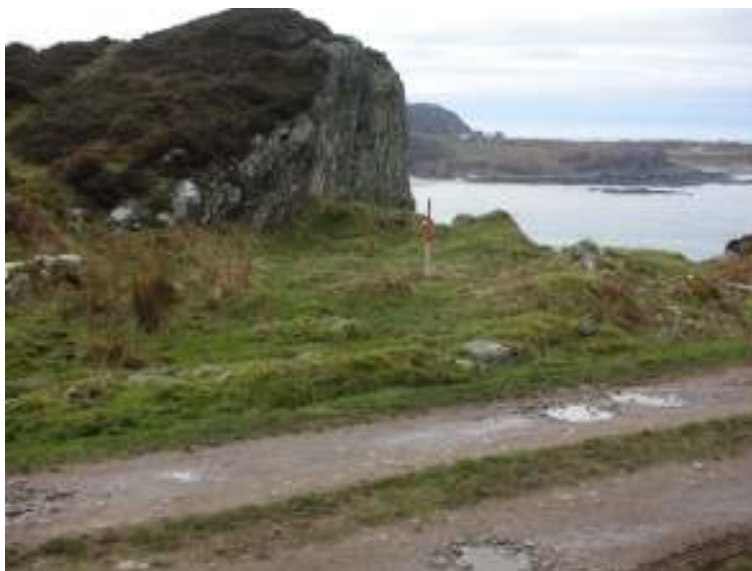
Site 110: Ruined Structure

Rectangular structure with a natural rock face forming its NW side. Measures 9.0m by 4.0m with rubble walls up to 1.0m wide. The structure is attached to dykes at its SW and SE corners. This site had previously been recorded.

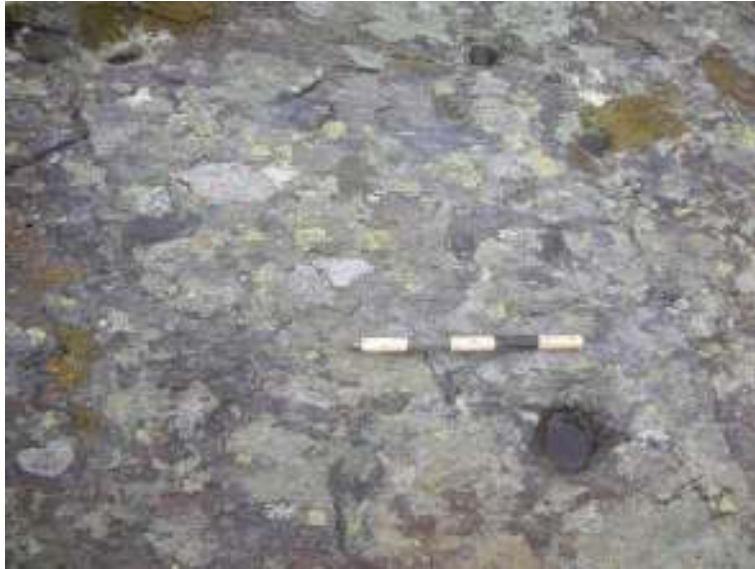
Site 114: Cup-marked rock

These cup marks were discovered by David Jardine on an exposed rock face lying above the cave. The rock bears at least 27 plain cup marks, the largest measuring 7.5cm in diameter and 5cm deep.

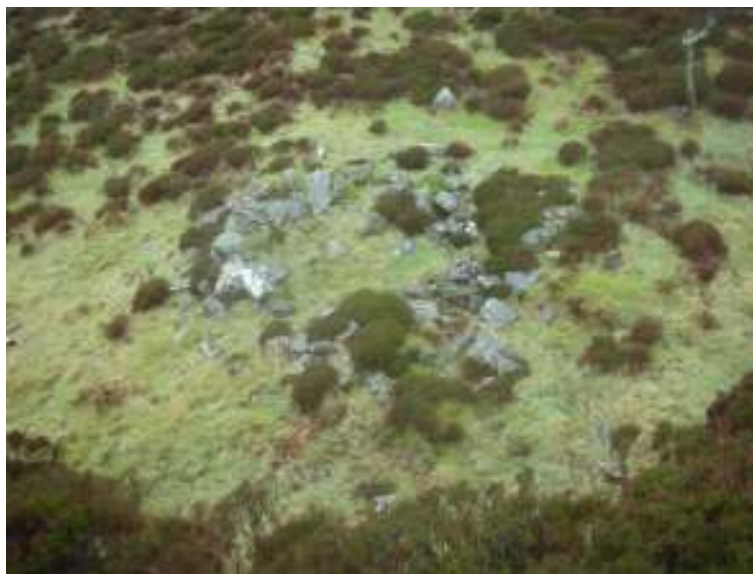
Site 119: Possible hut circle

Possible hut circle remains measuring 6.30m by 6.0m externally with walls 0.8-0.85m wide and entrance at S. There is some disturbance on the E side which may be a later modification. A possibly associate dyke (11m long) lies through a gully at the NE at NR 41882 98216.

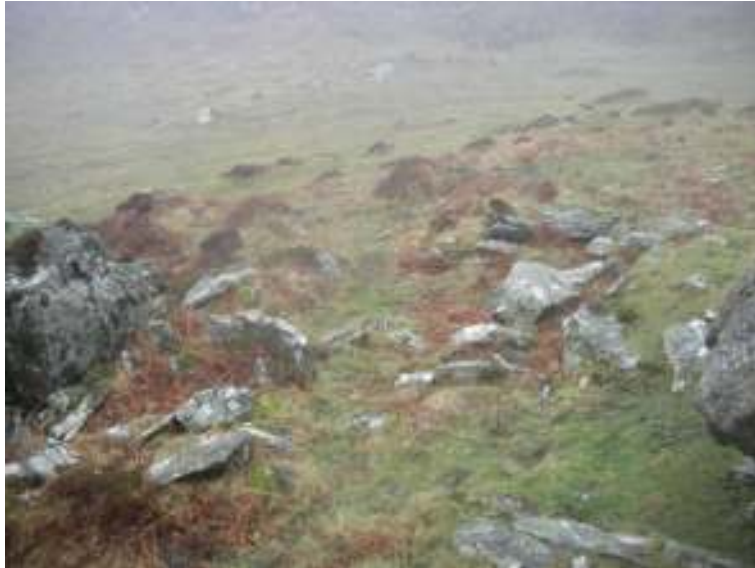
Site 123: Structure

A sub-rectangular structure constructed amongst natural boulders. The structure measures 4.40m by 3.70m with a possible extra cell or modification at the E.

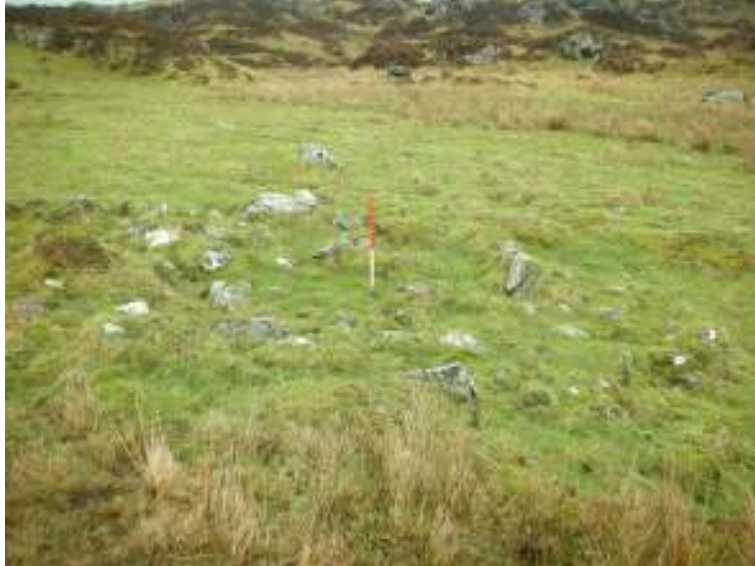
Site 133: Possible hut circle

- 133) Structure? and Enclosure. Cnoc Ormadail, NR 41544 99149 43m.  
A sub circular stone spread that may represent a structure c. 6.0m in diameter. The possible structure sits at the S end of a raised and dyke enclosed terrace 924m by 13m.

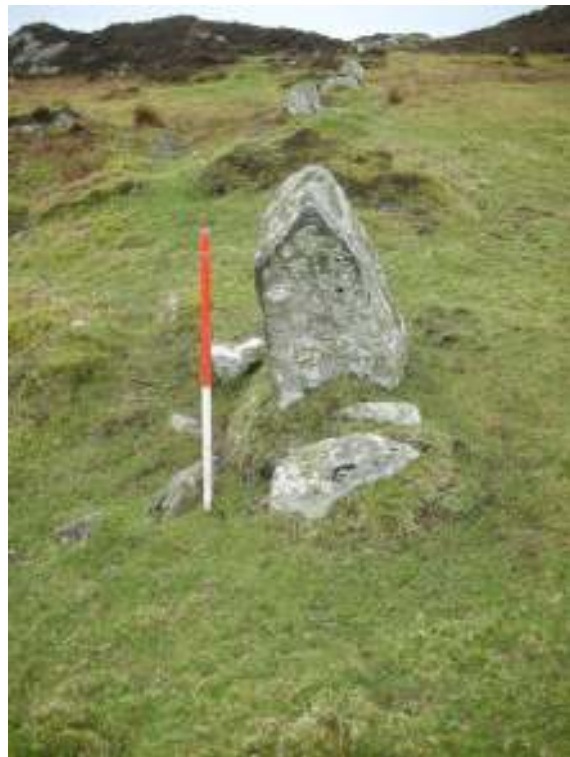
Site 134: stone and turf dyke

134) Dyke. Cnoc Ormadail, NR 41589 99053 28m - NR 411550 99061.  
A NW/SE aligned turf and stone enclosure dyke.

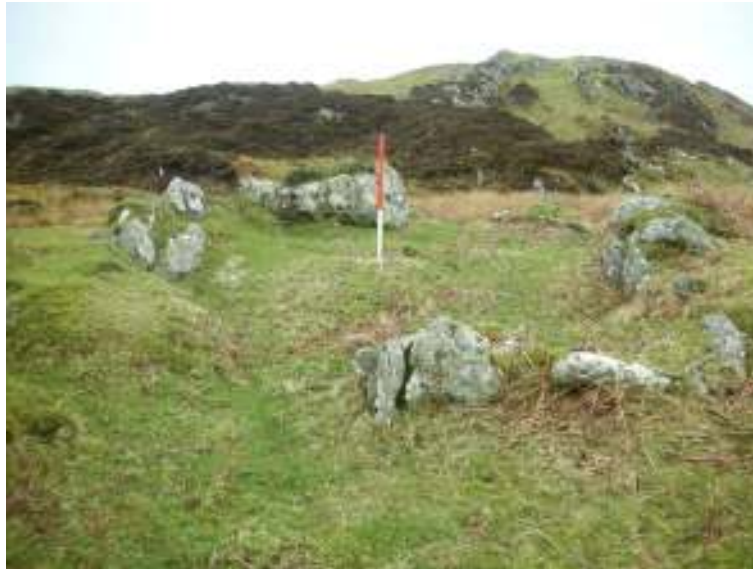
Site 137: Structure utilising natural rock face

A rectangular structure built against a natural dyke which forms its E side. Measured 3.50m by 2.80m internally with walls up to 0.60m wide and 0.60m high.

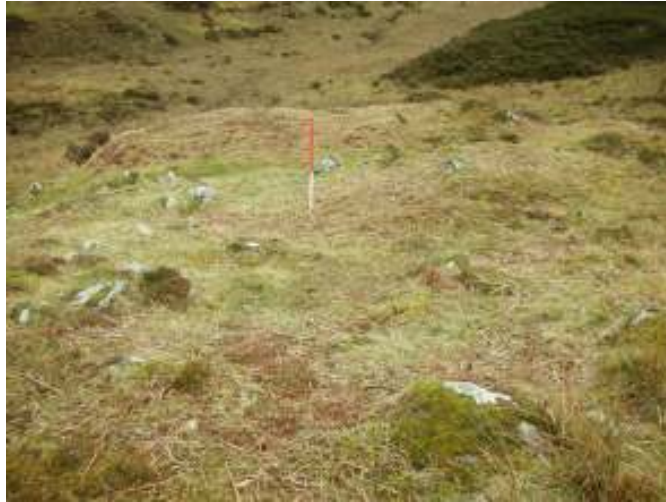
Site 147: Turf and stone structure

An oval shaped turf and stone structure oriented N/S measuring 10.0m by 4.0m.

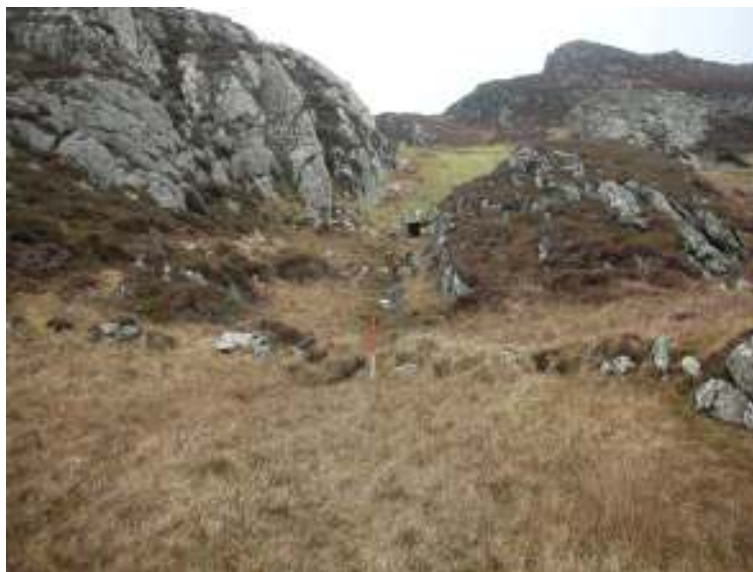
Site 154: dyke below Tober Challium Chille

A previously recorded curving length of stone and turf dyke closing off a gully below well Site 213. A stone wall, approximately 12m long by 0.5m wide extends between two bedrock outcrops. It is constructed of angular boulders and is oriented SE-NW. It is covered in grass and heather and lies within a marshy area.

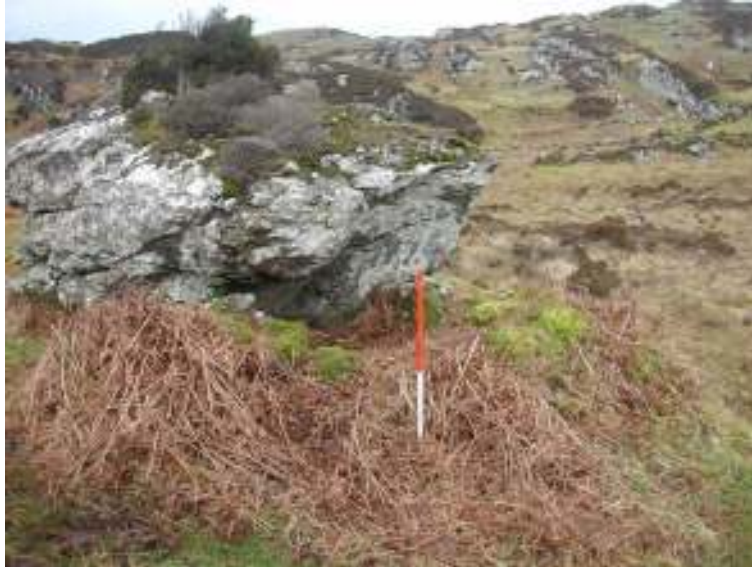
Site 167: Twinning pen

A twinning pen constructed against the face of a large natural boulder, measures 3.0m wide externally.

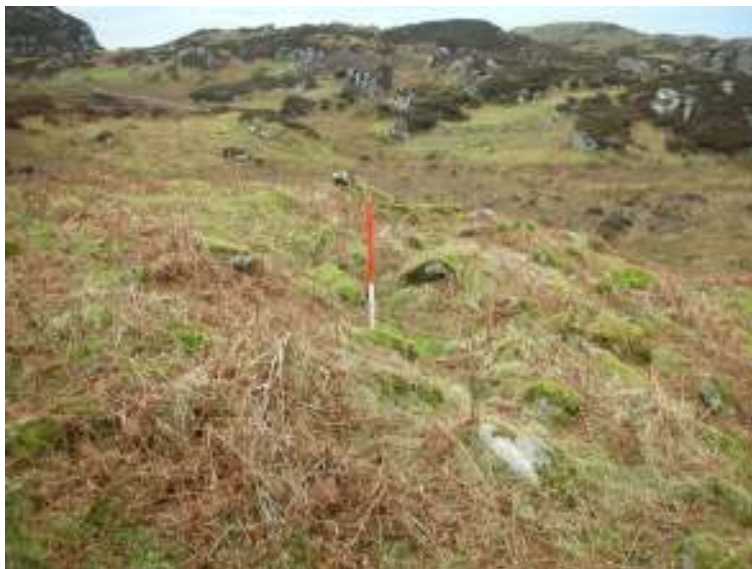
Site 168: Structure

The oval remains of a building partially cut into the natural slope, measures 7.50m by 4.0m externally with rubble walls 0.62m high.

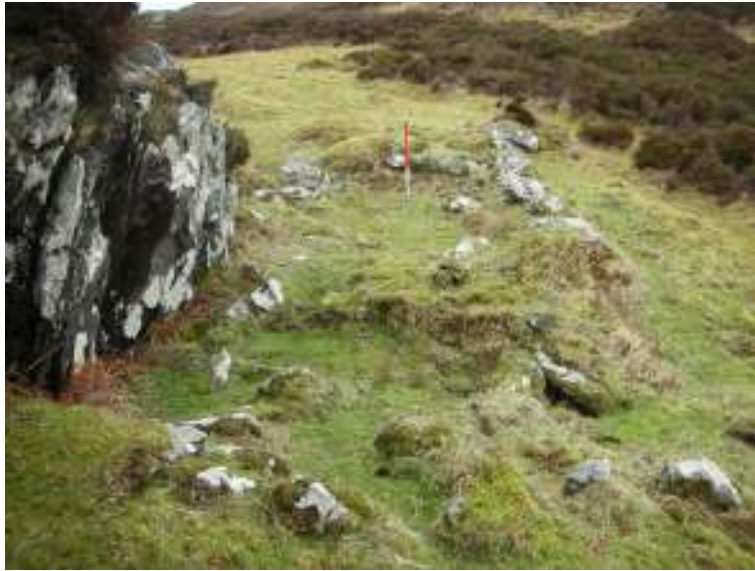
Site 169: Structure

A two-celled rectangular structure built against the N face of a natural overhang. Measures 7.0m by 4.5m externally with the E cell measuring 2.60m by 2.20m and the W cell 3.20m by 2.30m internally. The walls stand up to 0.54m high in three rubble courses.

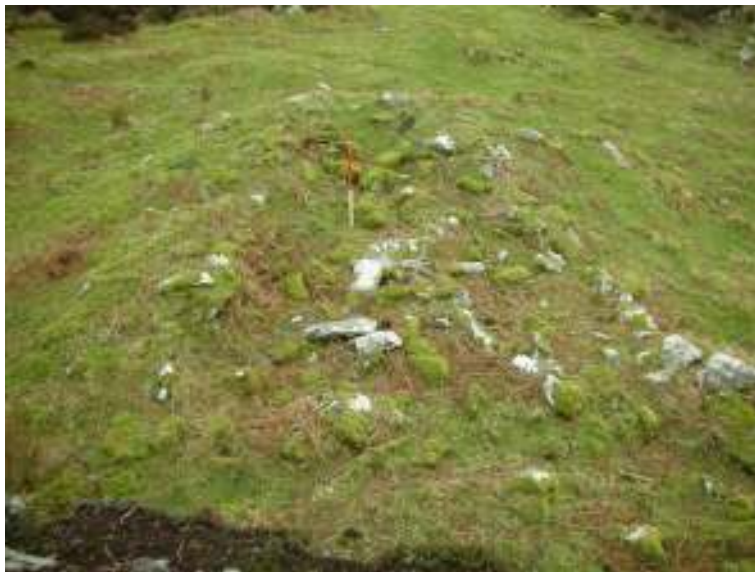
Site 170: Tumbled structure

A badly tumbled structure measuring 7.50m by 4.0m externally surrounded by rig and furrow cultivation.

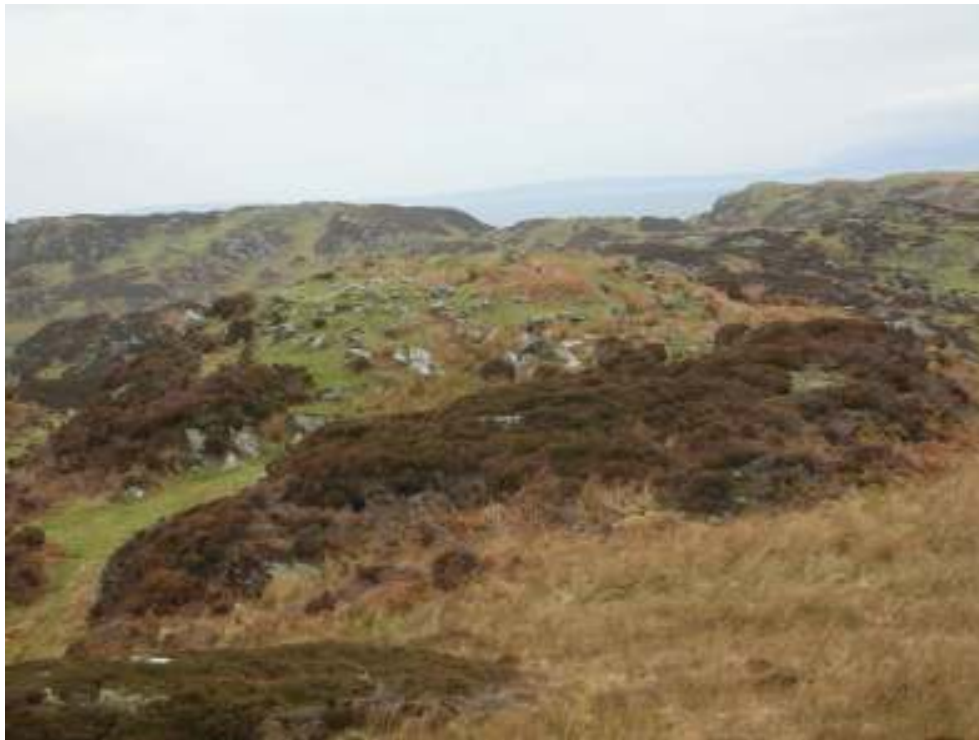
Site 172: Ruined dun structure

It is likely this is the Dun Mor referred to by Loder (Loder 1935) which was perhaps misidentified by Piggot (Piggot & Piggot 1948) as another site nearby (of which there are many) and subsequently dismissed by RCHAMS when visited in 1974 as a clearance cairn, NMRS Site Number NR49NW 6, Canmore ID 38210.

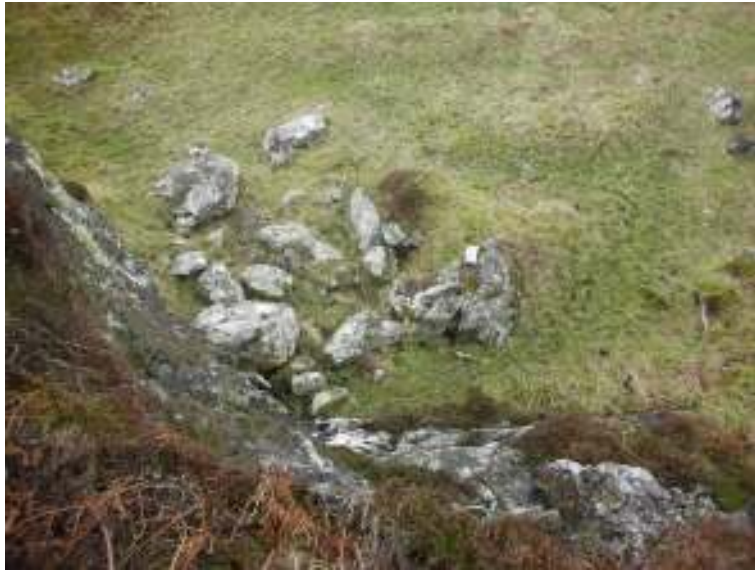
Site 173: small structure below dun

A small structure built against a natural rock face below the dun, measures 1.50m in diameter.

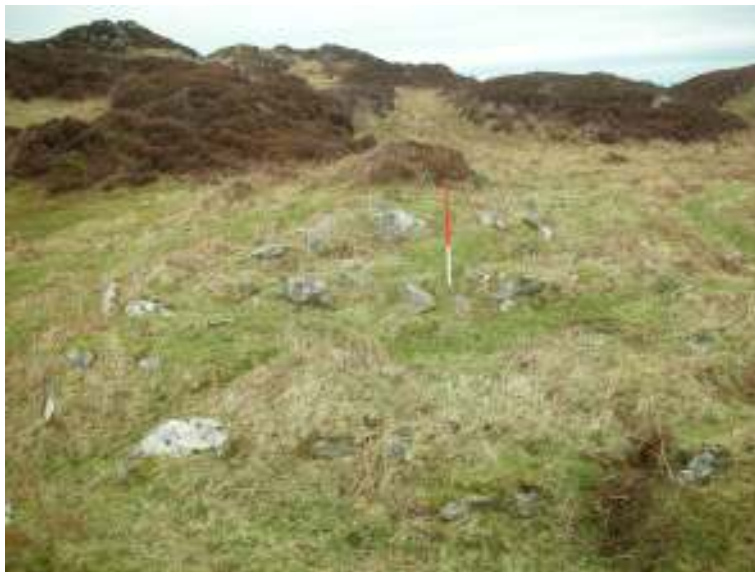
Site 174: sub circular structure

A sub circular structure measuring 7.40m by 6.90m externally with walls up to 1.10m wide. A clearance cairn lies 15m to the NW.

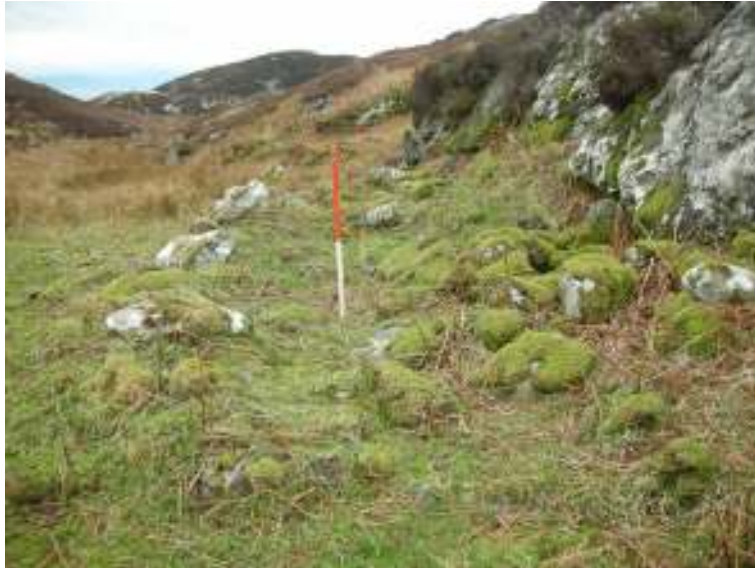
Site 175: Structure

An oval structure constructed against a natural rock face, measures 6.0m by 3.0m with walls standing 0.55m high and up to 0.70m wide. A twinning pen has been constructed over the earlier structure measuring 1.50m by 1.50m. There are rig and furrow remains to the W.

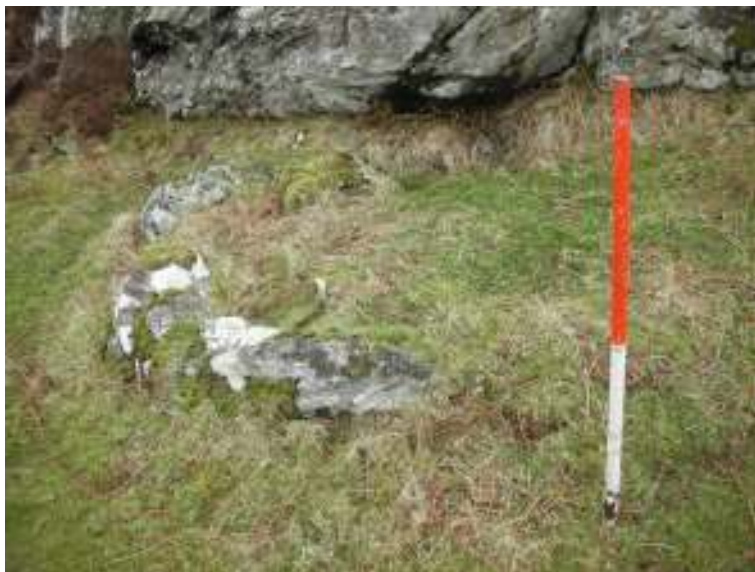
Site 178: small structure

A small rubble built structure constructed up against natural scarp, measures 1.8m wide.

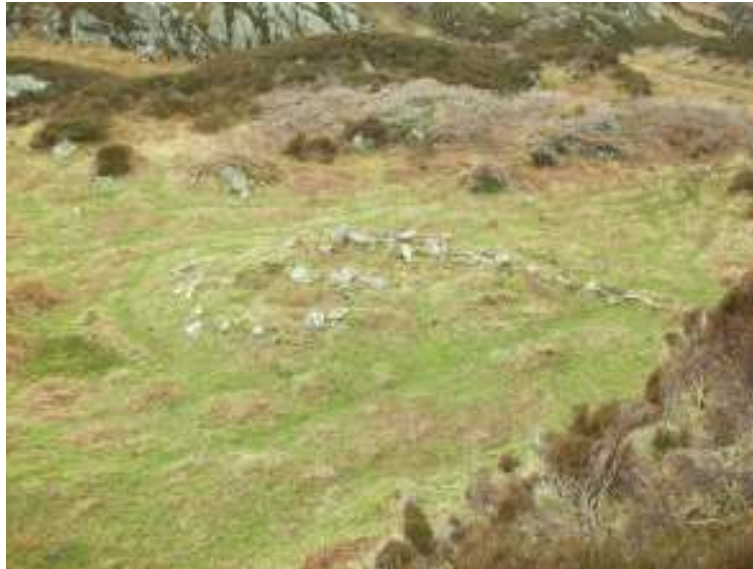
Site 179: Structure

An oval building situated on a level terrace. The remains of the rubble walls measure 6.0m by 4.20m with an entrance at NE. An internal wall divides the structure into two rooms and an enclosure wall links the building to a natural scarp at the NE.

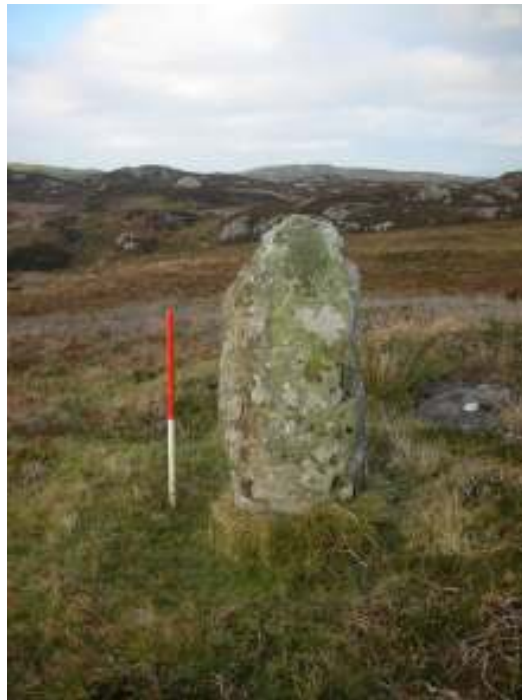
Site 206: standing stone

Situated on the SW flank of Cnoc a' Charraigh (Hill of the standing stone) about 1.1km E of Balnahard farmhouse there is a standing stone. It is 1.4m high, measures 0.5m by 0.4m at the base with its long axis aligned E and W, and rises with straight sides to a pointed top. About 1-2m to the N there is a prostrate slab measuring 2m from N to S by 0.8m transversely and at least 0.2m in thickness: it has been described as the cover stone of a cist.' but is probably a fallen standing stone.
