## **BALNAHARD FARM COLONSAY**

### **ARCHAEOLOGICAL WALKOVER SURVEY**

### **Data Structure Report**

**May 2012**

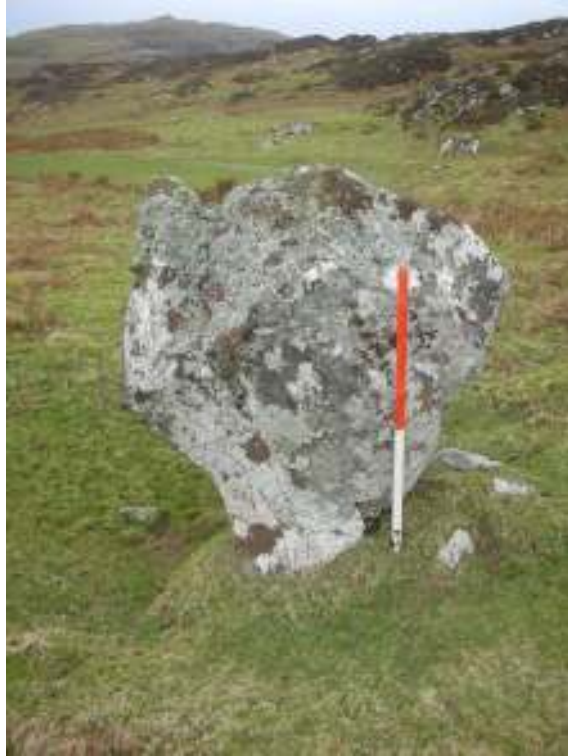
Site 211: Gruagach Stone

Area NR 415 997: Clach na Gruagach - Stone of the Gruagach or Fairy Woman - an irregular boulder 5' high and narrowing to the base where there is stone packing. A shallow recess in the top received the offering of milk, and thin ridges running round the stone are said to be caused by ropes which once bound the Gruagach to it.
